ECCI of AlGaN/GaN HEMT structures grown on Si

D. Thomson¹, G. Naresh-Kumar¹, B. Hourahine¹,
C. Trager-Cowan¹, P. Wright² and T. Martin²

¹*Dept. Of Physics, SUPA, University of Strathclyde, Glasgow G4 0NG*

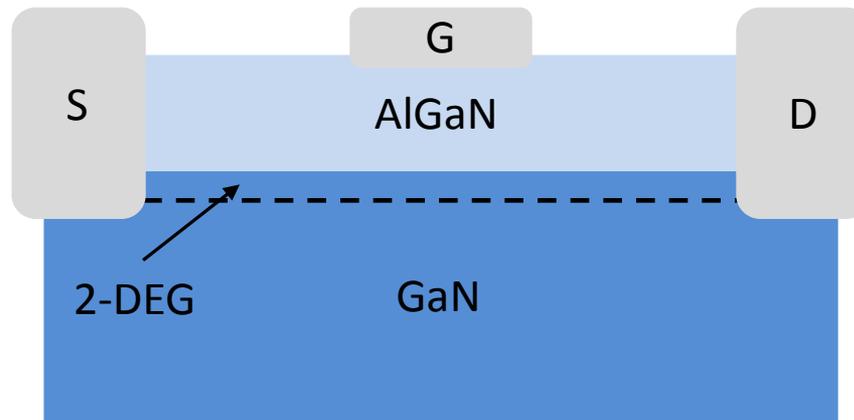
- HEMT - High Electron Mobility Transistor
- Fabricated from 2 semiconductor materials with different band gap energies
- Can operate at higher frequencies and voltages than Si MOSFETs
- Higher power density, efficiency and operating temperatures
- Nitride HEMTs do not require doping to generate a 2-DEG

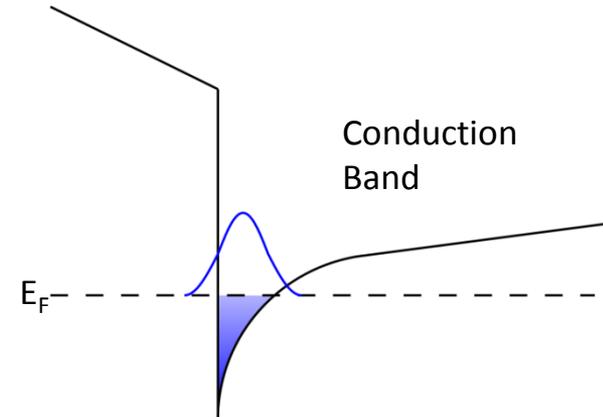
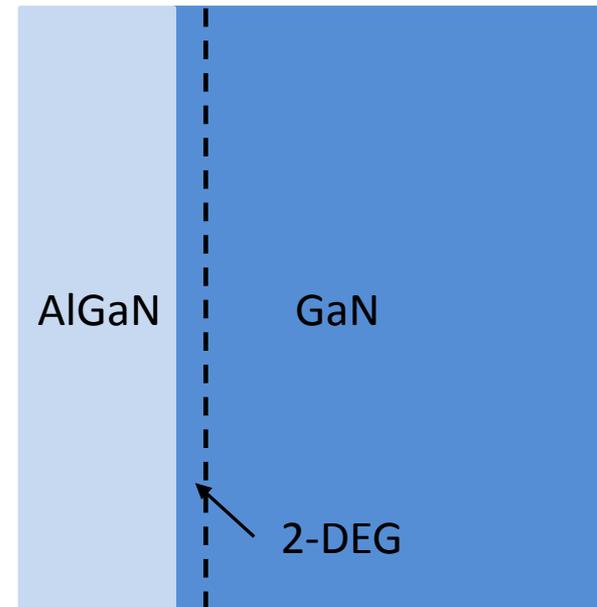
- 2DEG arises due to polarisation difference between layers
- Spontaneous polarisation
 - Intrinsic to the material
 - Arises due to crystal structure
- Piezoelectric polarisation
 - Arises due to difference in lattice constants between layers
- Larger 2DEG density leads to better device efficiency
- 2DEG density controlled by applying a voltage to the gate contact

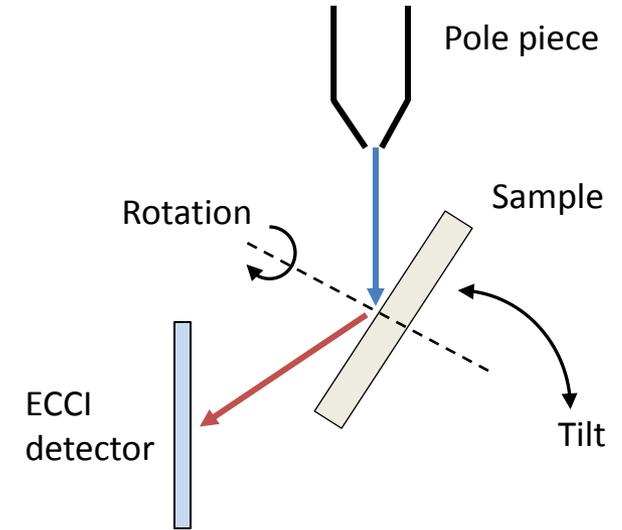
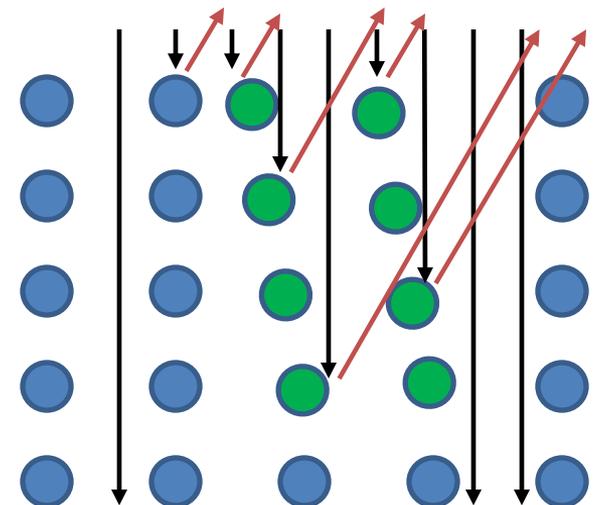
- Sample is oriented to allow electron channelling – that is electrons are diffracted by the crystal lattice
- Changes of the crystal lattice change backscattered electron intensity
- Diffracted backscattered electrons are used to produce an image showing strain associated with dislocations
- Images also show crystal grains with different orientations
- Depth resolution of tens of nanometers

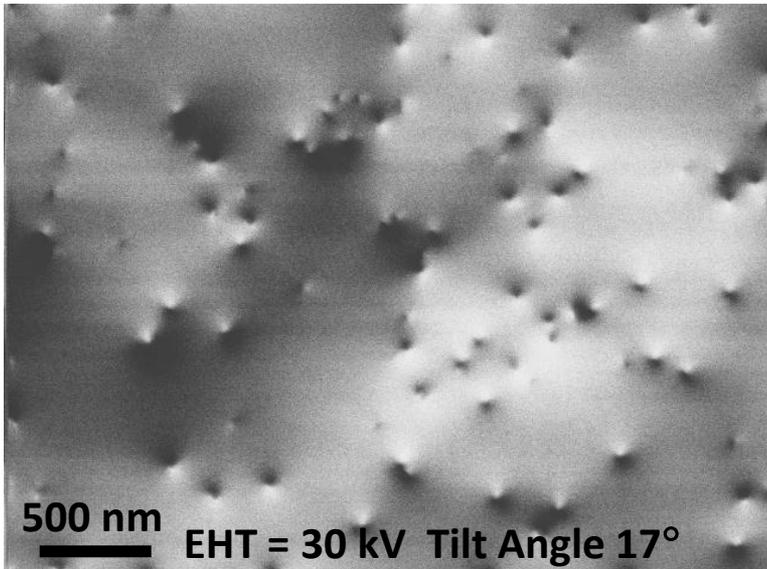
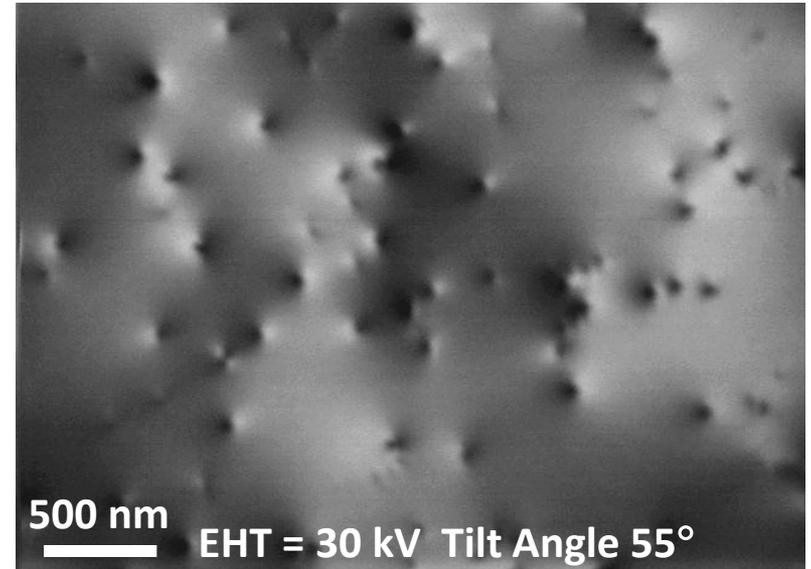
Electron channelling contrast images from a 900 nm thick GaN thin film

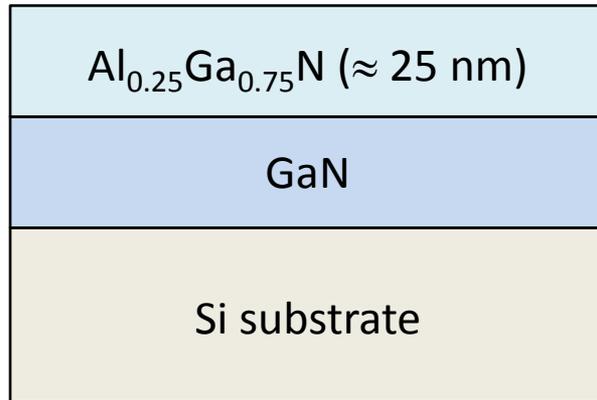
- 2 AlGaN/GaN Samples grown on a 6" Si wafer
 - Both samples grown using the same procedure
 - Sample A is uncapped
 - Sample B has a GaN capping layer

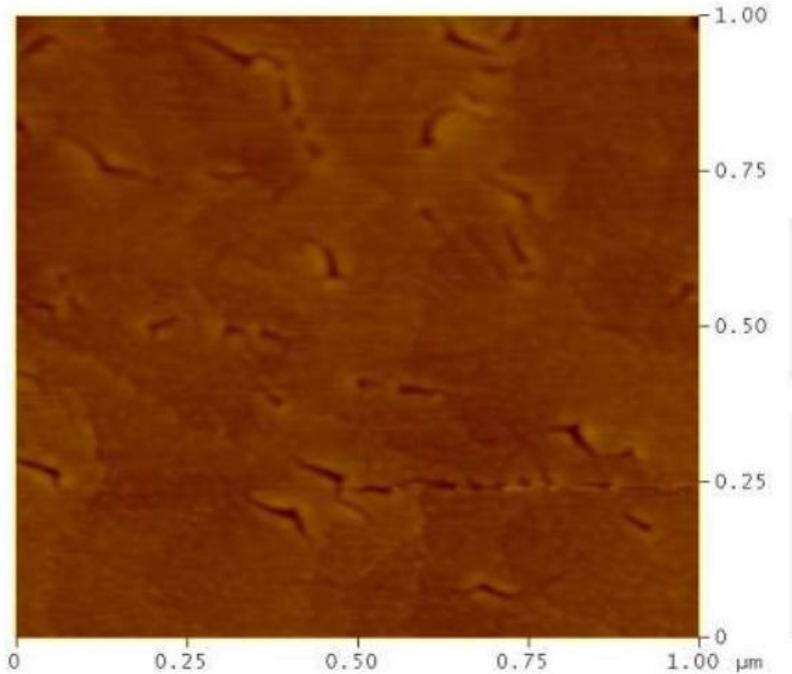
AlGaN surface

- Atomic force microscopy (AFM) measurements of similar capped & uncapped AlGaN/GaN samples

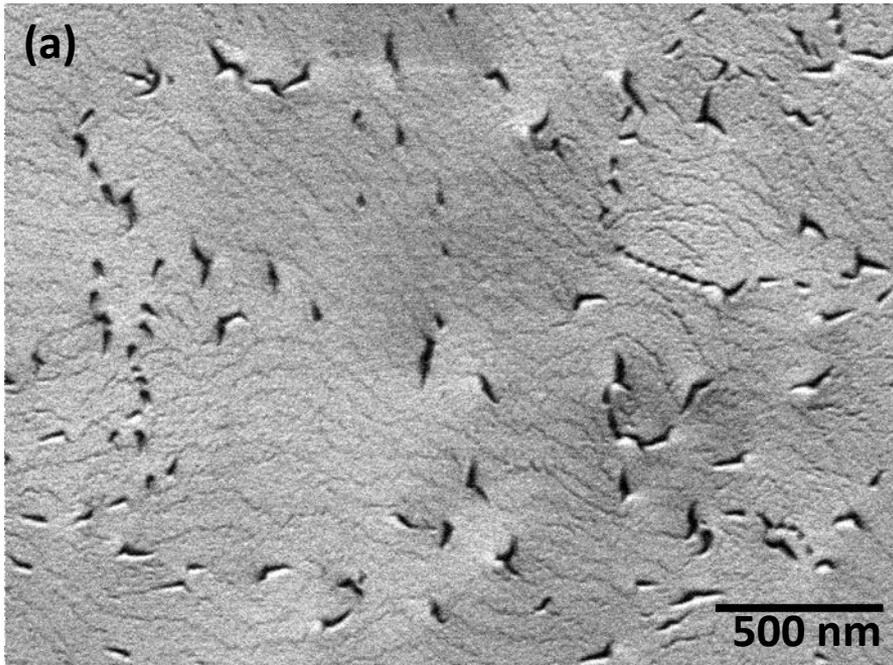
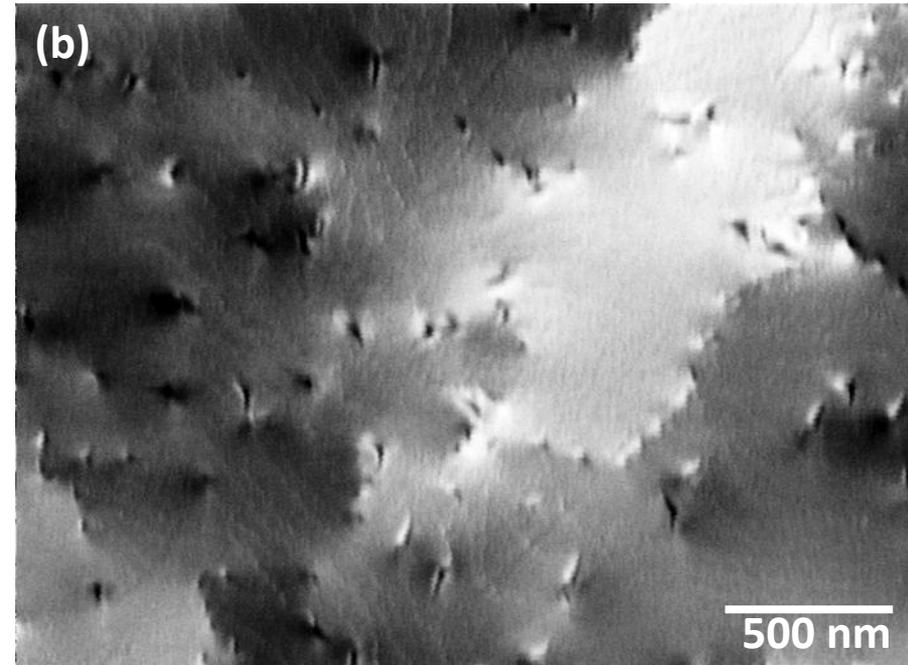
- Sample A
- Uncapped AlGaN/GaN
- Fissure density $\approx 2 \times 10^9 \text{ cm}^{-2}$

ECCI of AlGaN surface from sample A in (a) backscatter and (b) forescatter detector geometries

- Formation of fissures on sample A most likely occurs during cooling after growth
- GaN capping layer on Sample B prevents fissures from forming
- Fissure density of similar number to dislocation density in capped sample
- Backscatter ECCI detector geometry provides good topographic images
- Forescatter ECCI detector geometry provides good dislocation & grain boundary contrast
- Fewer dislocations visible in the BS geometry in the capped sample – possibly due to diffraction conditions
- Extended defects parallel to the sample surface are seen in both samples – possible misfit dislocations or stacking faults

- Nanoscale fissures are observed on the AlGaIn surface
- No fissures are observed on the GaN capped surface
- GaN capping layer prevents formation of fissures in the AlGaIn
- Fissure density was estimated to be $2 \times 10^9 \text{ cm}^{-2}$
- Fissures are associated with threading dislocations (TDs) and they are possibly due to all three types of dislocations
- Dislocation density for the GaN capped sample was estimated to be $5 \times 10^9 \text{ cm}^{-2}$
- Difference in TD density between the samples is within the expected variance across a 6 inch wafer
- Extended defects parallel to the surface have been observed in both samples
- Further investigation is required to identify the types of dislocations in the samples

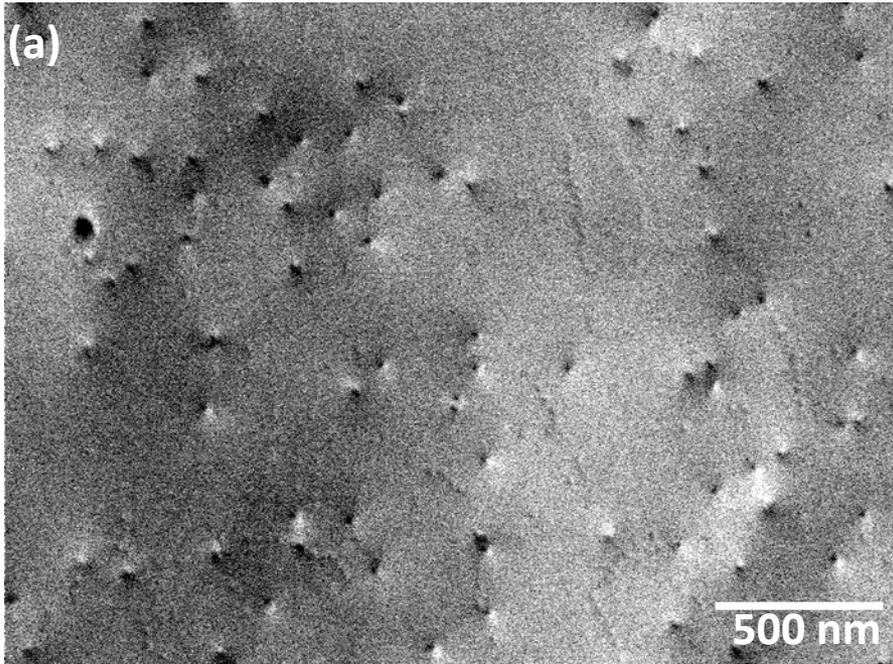
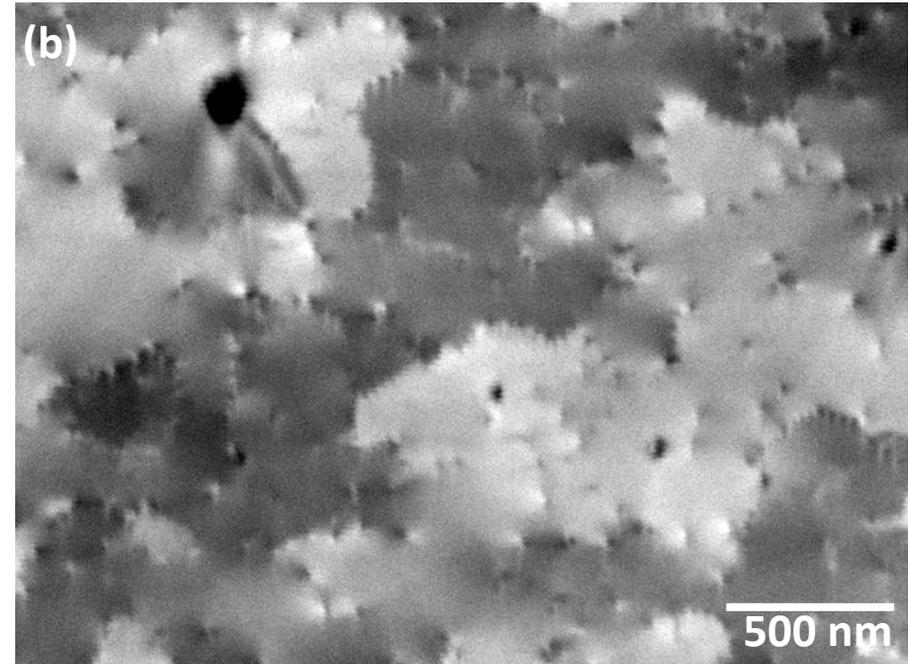
- Sample B
- GaN capped AlGaN/GaN
- Dislocation density $\approx 5 \times 10^9 \text{ cm}^{-2}$

ECCI of GaN cap from sample B in (a) backscatter and (b) forescatter detector geometries

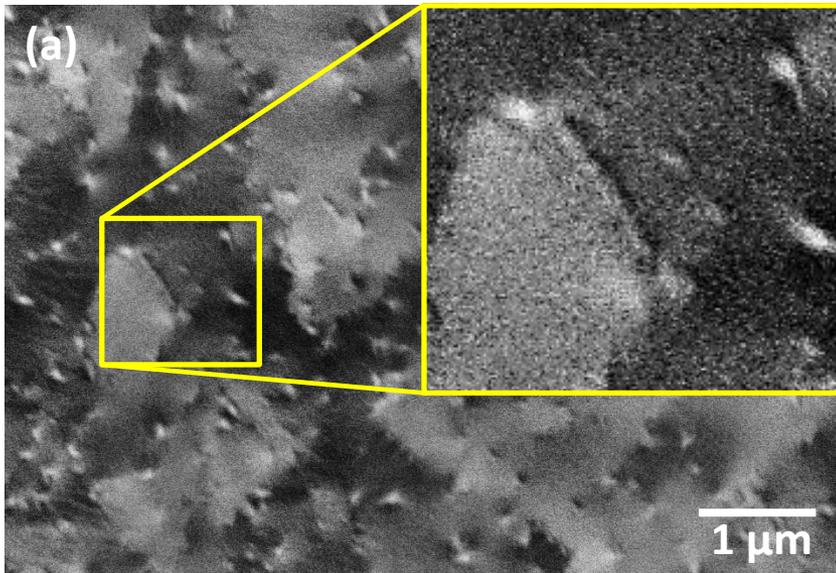
Sample A

- Extended defects parallel to sample surface present in both samples

ECCI images of (a) sample A and (b) sample B showing extended defects parallel to the sample surface
